Flightfax

ARMY AVIATION
RISK-MANAGEMENT
INFORMATION

MAY 2004 ♦ VOL 32 ♦ NO 5

Post-Crash *Fires:* a deadly **Hazard**

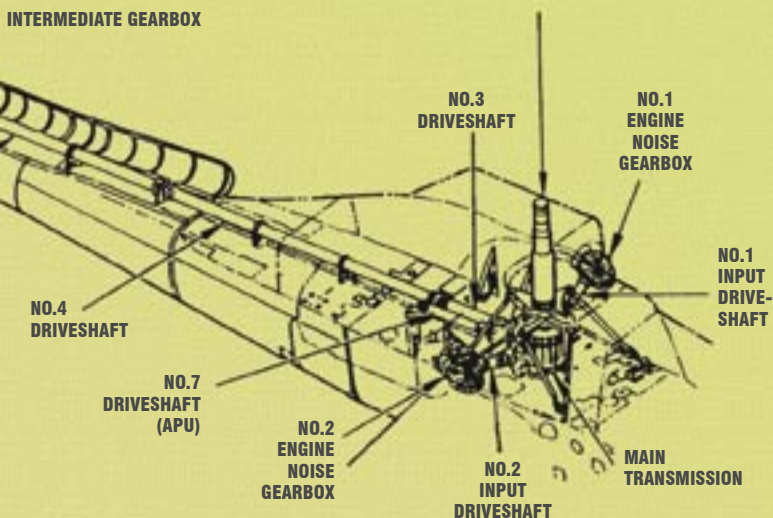
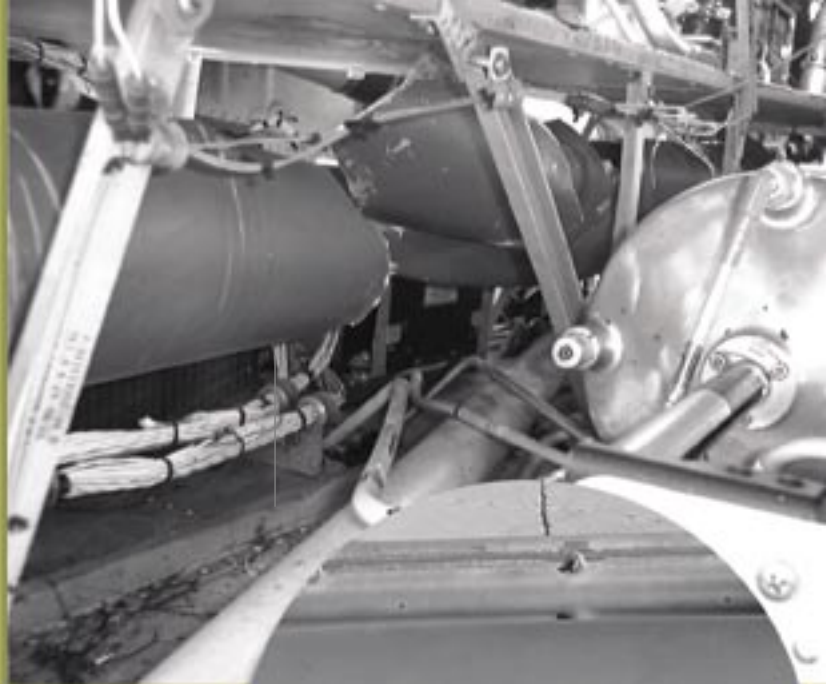
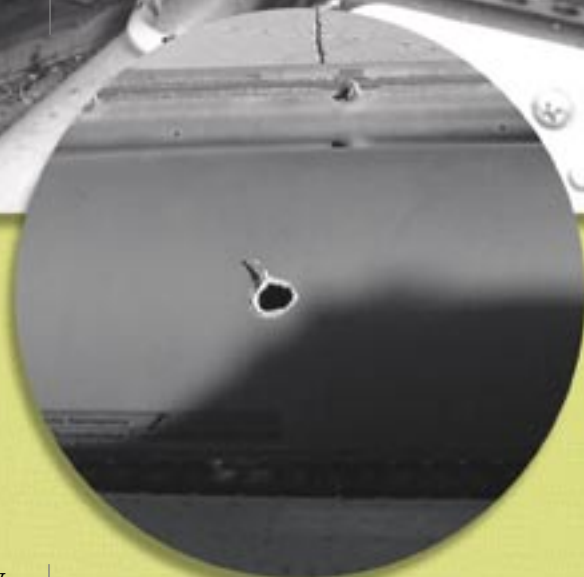
explosion the tail rotor came to a complete stop, as witnessed by the CE. Upon further inspection, the number four tail rotor driveshaft was found to have twisted apart just forward of the aft anti-flail assembly.

Accident investigators inspected much of the aircraft's drive train system and found nothing wrong with the driveshaft other than the obvious damage. What they did find was that during the number two engine start sequence, the overriding input drive clutch either failed to engage initially and then suddenly engaged; or the clutch was engaged, suddenly disengaged, and then re-engaged immediately afterward. At any rate, there was damage to the number two engine drive clutch indicating some kind of sudden engagement. This sudden engagement caused a severe

shock to the drive train, causing it to fail at the weakest point.
